US005733062A

[54] HIGHWAY CRASH CUSHION AND COMPONENTS THEREOF

[73] Assignee: Energy Absorption Systems, Inc., Chicago, Ill.

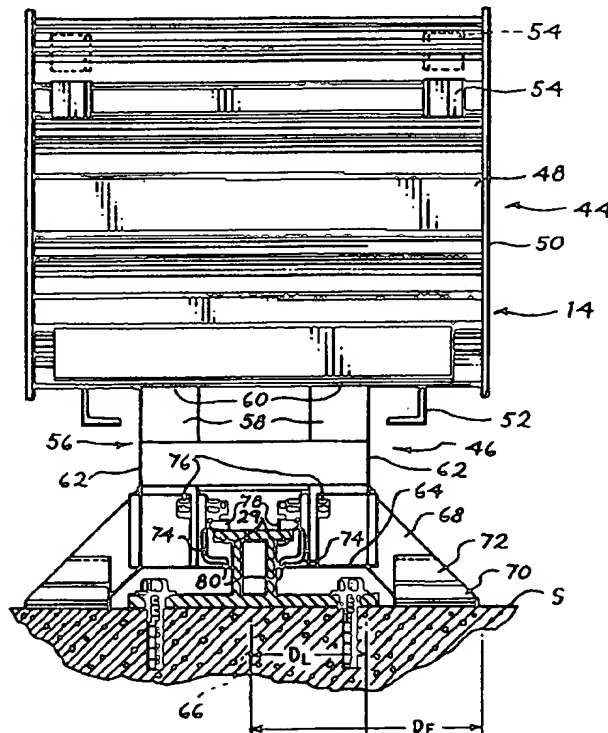
A highway crash cushion includes a single, central, rigid, guide rail that guides the crash cushion in axial collapse. Diaphragm assemblies are each provided with recessed legs, and a central guide that slides along the rail while locking against the rail in a lateral collision. The diaphragm assemblies support fender panels that include four longitudinally extending ridges, a central slot, and a tapered trailing edge that reduces vehicle snagging. Energy absorbing elements are disposed between the diaphragm assemblies, and each includes an indicator that clearly indicates when the element has been compressed and possibly damaged.
